Korenix JetNet Industrial Managed Switch JetNet 4510 SOFTWARE RELEASE Notes

About This Software Version

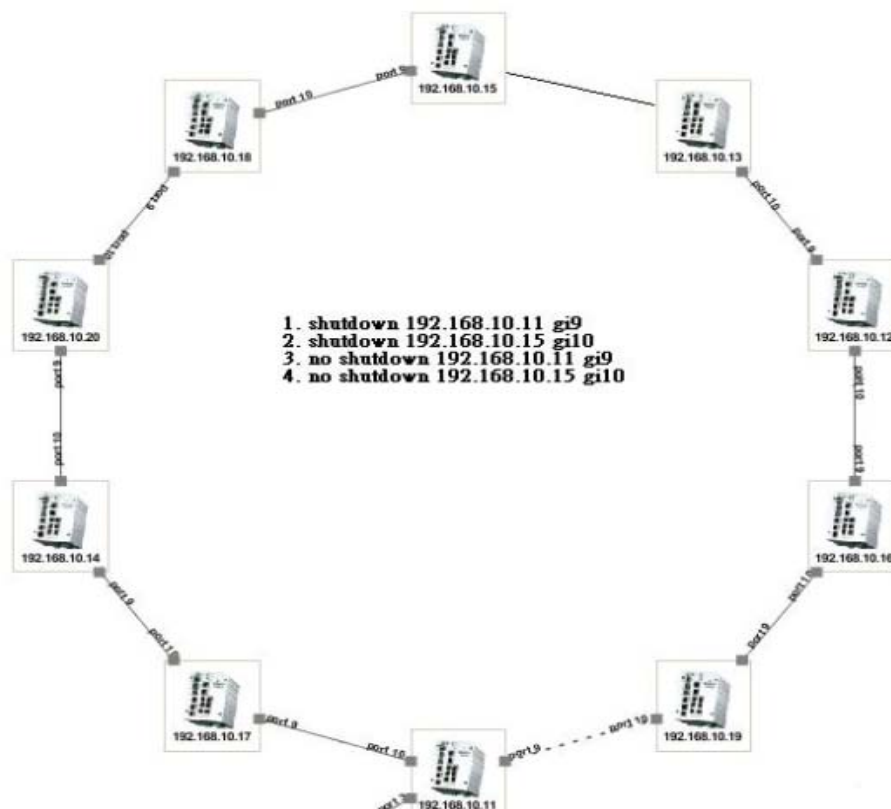
- Super Ring v2 can't run with LLDP function. (#1142)
- As the ring topology as below, link down /up active ring path will cause the ring status show "Abnormal" when this architecture working with JetView Pro for 2 days, also one of DUT will not be discovery by JetView Pro utility (# 1143,1144)

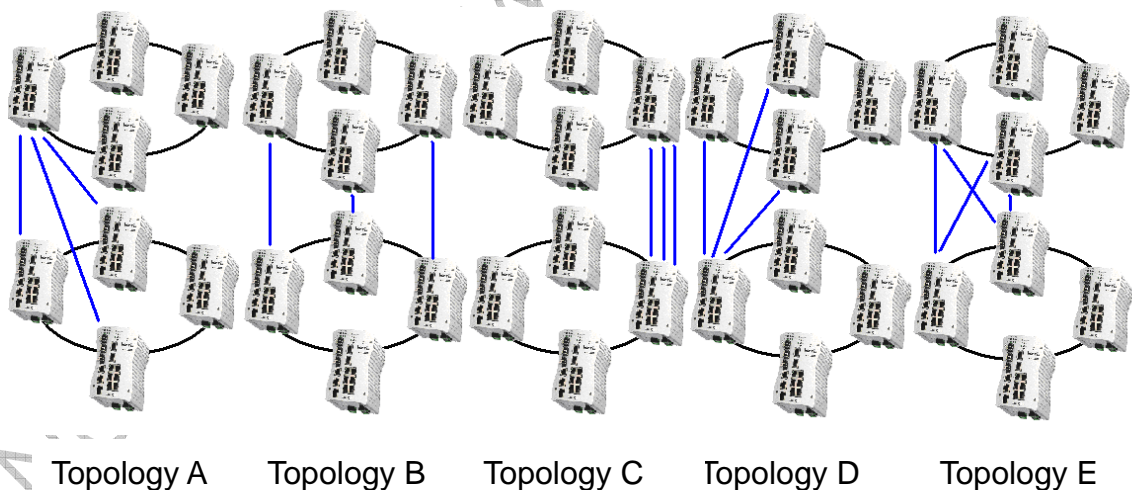
- Recovery time of node down in topology B and D is over than 1 sec (# 1016), see attached diagram as following.
