## Korenix JetNet Industrial Managed Switch 5010G SOFTWARE RELEASE Notes

### About This Software Version

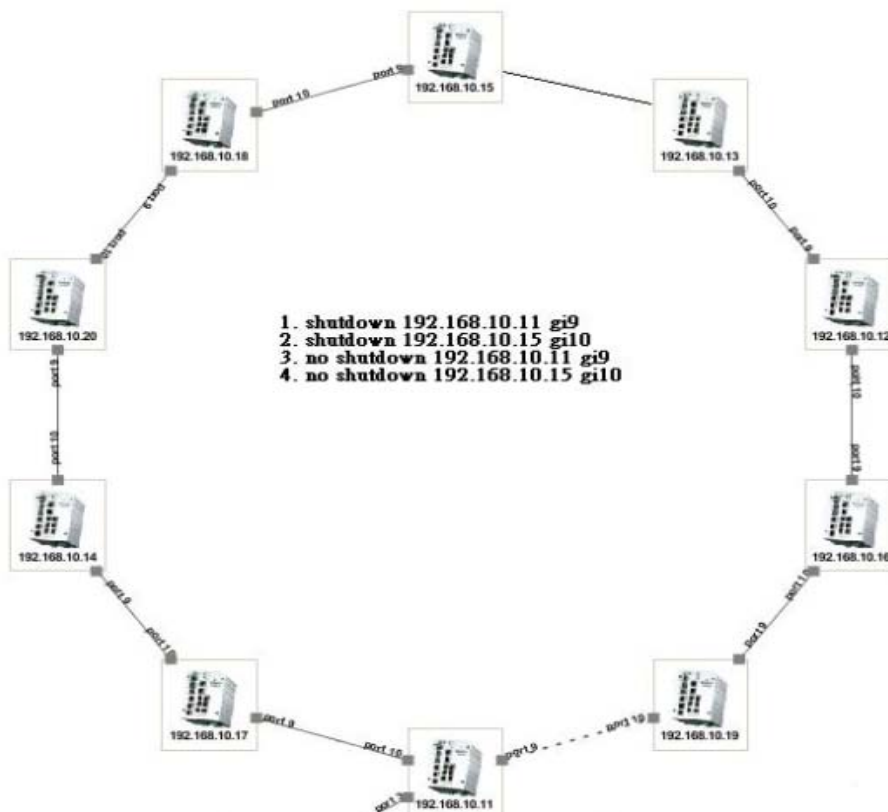
- Bootloader v1.6.2.12 should use firmware 2.1 or above.
- Super Ring v2 can't run with LLDP function. (#1142)
- As the ring topology as below, link down /up active ring path will cause the ring status show "Abnormal" when this architecture working with JetView Pro for 2 days, also one of DUT will not be discovery by JetView Pro utility (bug# 1143,1144)

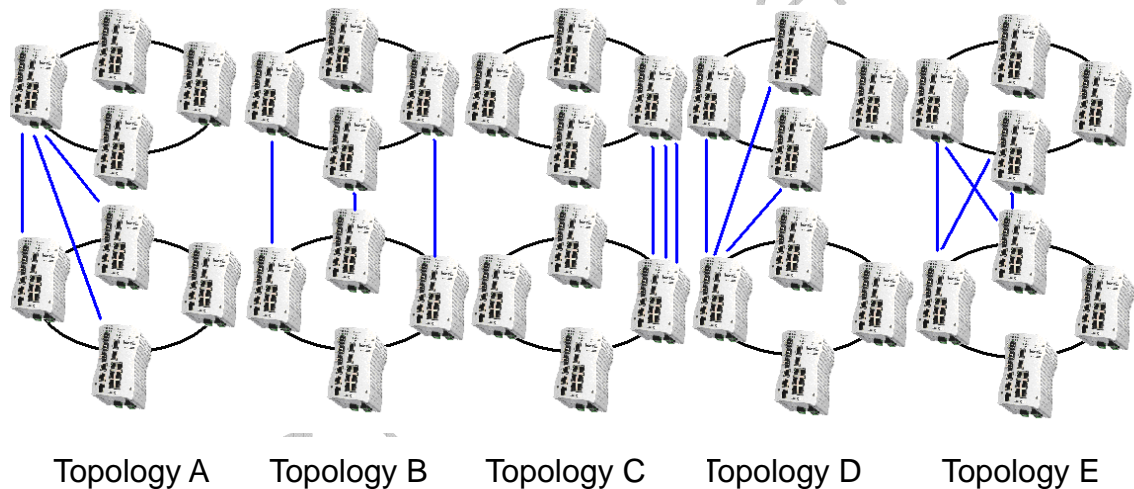
- If link up Dual Homing port more than 7 ports, it will lead to DUT work abnormal. (eg. Viedo) (# 949).
- It will lead to disconnect when PC2 ping PC1 if we node down any DUT in nondual-homing ring (# 961).
- It will take duplicates when we do node up and the recovery time is more than 1 sec (# 981).
- If we change querier's IP, DUT will not change querier (# 1003).
- In the SNMP management mode, the DUT does not restrict aggregate port as trunk group when one is 802.1x enabled.(# 1008).
- Recovery time of node down in topology B and D is over than 1 sec (# 1016); see attached diagram as following.
