## Korenix JetNet PoE Switch- JetNet 3706f SOFTWARE RELEASE Notes

JetNet 3706f Firmware Release Note

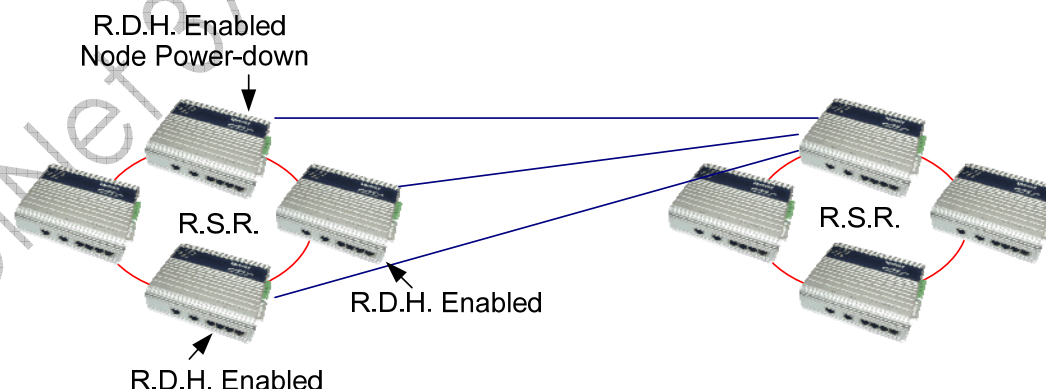
- Boot loader v1.6.4.3 should use firmware 2.1 or above.
- The system can't downgrade to V1.0 after firmware upgrade to version 2.1.
- In the ring topology, the recovery time of node power-up is around 30 seconds.
- In the RSTP interoperability testing case- JetNet 3706f connects 3 paths to Cisco 2950. It will cause uplink port state change to forwarding mode and start looping when Root Switch changes from JetNet 3706f to Cisco 2950.
- As following topology, the recovery time of node ( R.D.H. enabled) power-down may take over 1 sec.

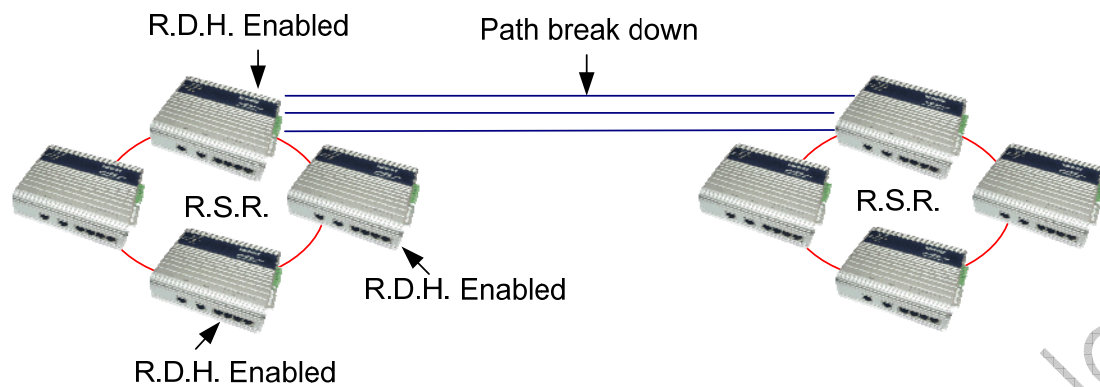
- As following topology, when plugged-out the link path will cause duplicated packet occurred between 2 rings.
